FILE NO.: HDC2025-004

NAME: Narkinsky House - Certificate of Appropriateness

LOCATION: 515 S. Rock Street, Little Rock, AR 72201

**A. PROPOSAL/REQUEST/APPLICANT’S STATEMENT:**

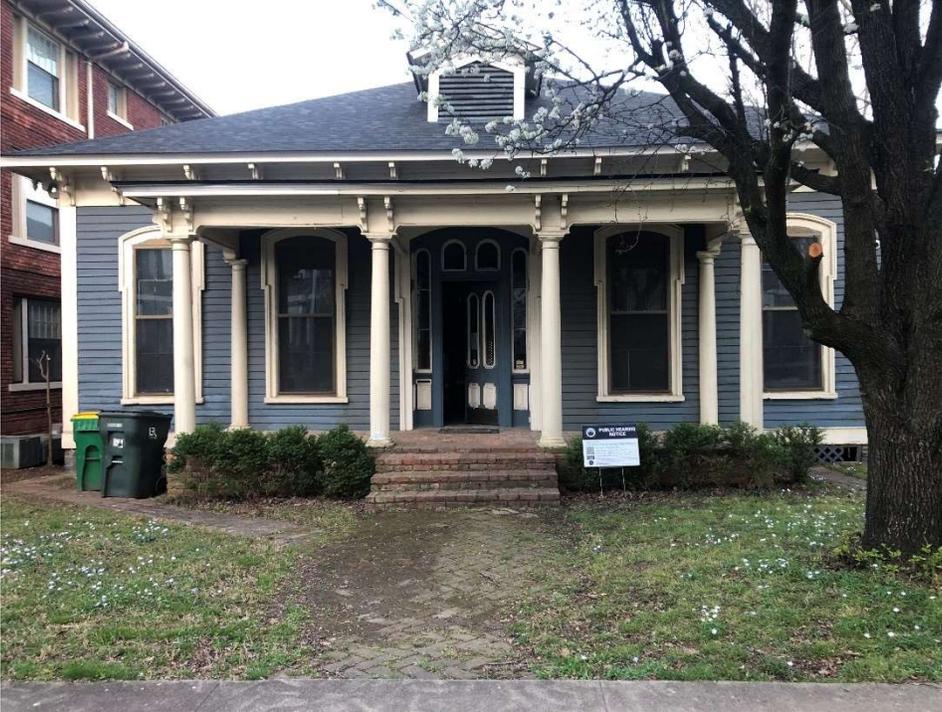
The application proposes several improvements and repairs to the front porch. These include installing new flashing and metal roofing, removing the non-historic, existing foundation (Figure 7), and reconstructing the pier and beam foundation displayed in the Narkinsky family photographs (Attachment D). The porch foundation will have a tongue-and-groove floor and foundation openings will be covered in lattice. The front steps will be rebuilt using brick, wood, or concrete, and black handrails will be added to meet code requirements.

*Figure 7. 515 S. Rock Street, front facade, 2025.*

1. Chimneys: The location and design of the reconstructed chimneys will be based directly on physical and documented evidence. Chimney flashing to be installed in step pattern in the mortar joints of the masonry. Brick masonry and mortar will match existing in dimension, scale, color, texture and other physical attributes.
2. Sidewalk: Reconstruction of the brick masonry sidewalk will be based directly on documented evidence. Additional engineering review and inspection is required by the Planning & Development Department to assure that the resulting sidewalk meets relevant accessibility and environmental codes.
3. Exterior Porch Light: New lighting will conform to Guideline 9.22 and require final review and approval by the staff.
4. Rear porch steps will be constructed of wood or concrete.
5. Front porch steps will be constructed of wood.

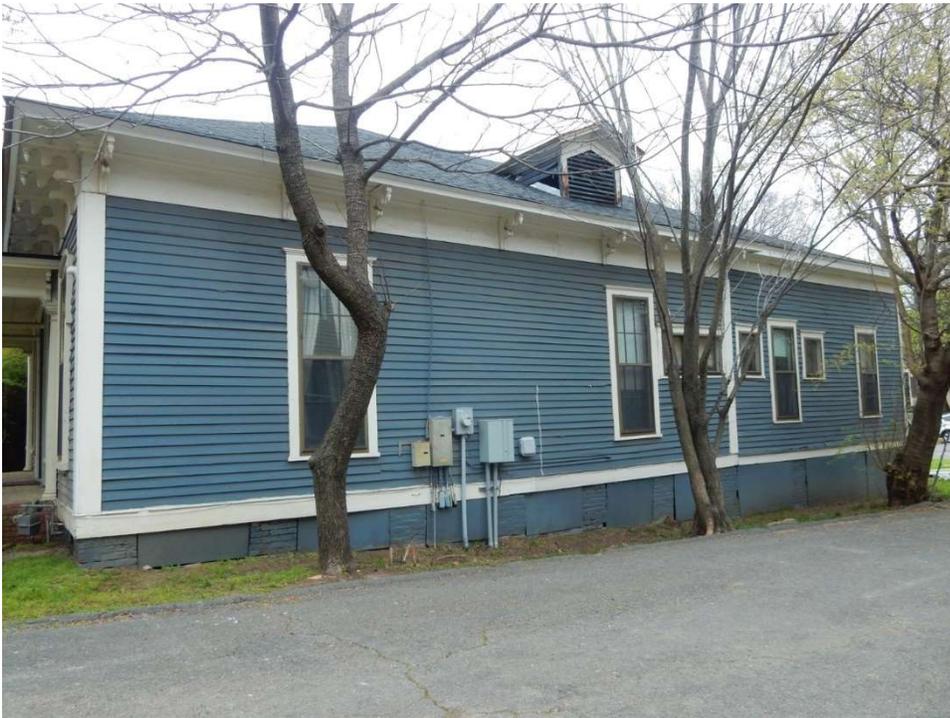
The application proposes realigning the exterior, horizontal trim boards on the historic rear addition with the trim boards of the original structure (Figure 9,12). The addition was constructed sometime between 1897 and 1913 and is considered to be historic. The misaligned trim boards showcase the expansion of the dwelling to accommodate the occupants and is historic in its own right (Attachment D).

Staff finds the realignment of the side elevation baseboards to be inconsistent with Guideline 4.8. The proposal alters an existing historic feature and is not substantiated by documentation.

*Figure 9. 515 S. Rock Street, south elevation, 2024.*

Staff recommends the approval of the application, as submitted, excluding approval for the realignment of the exterior trim boards and the replacement of the column base with substitute materials, with the following conditions:

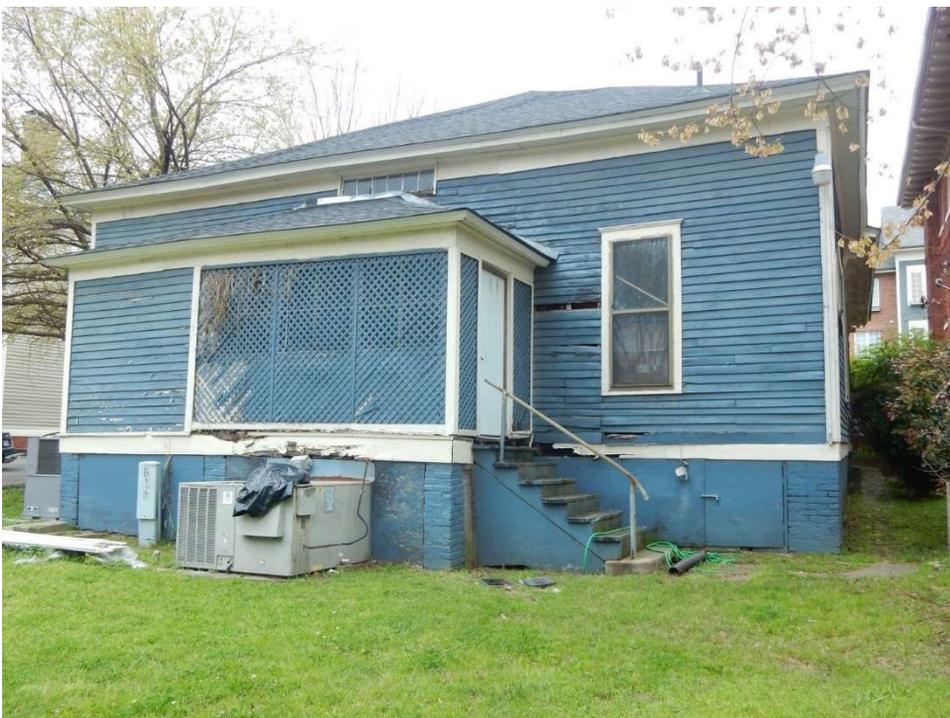
The application proposes replacing the rear porch steps with brick and the installation of a handrail (Figure 10). The existing wood steps are deteriorated and require replacement. As currently constructed, the steps and risers do not meet code. The rear of the structure, inclusive of the steps, is visible from the public alley.

Staff finds the replacement of the rear steps to be necessary and finds the proposed material to be inconsistent with Guideline 4.13 (1). Staff finds that brick steps may appear as conjecture and that concrete steps would be more appropriate. The rear steps are not protected by a covering, were humbly constructed, and are located on the rear façade. Concrete is a more compatible replacement as it is simple in design and affords durability. Additionally, the proposed porch handrail is consistent with Guideline 4.13(7) and is simple and subordinate in design and compatible with the historic attributes of the property.

*Figure 10. 515 S. Rock, rear elevation and rear enclosed porch, 2024.*

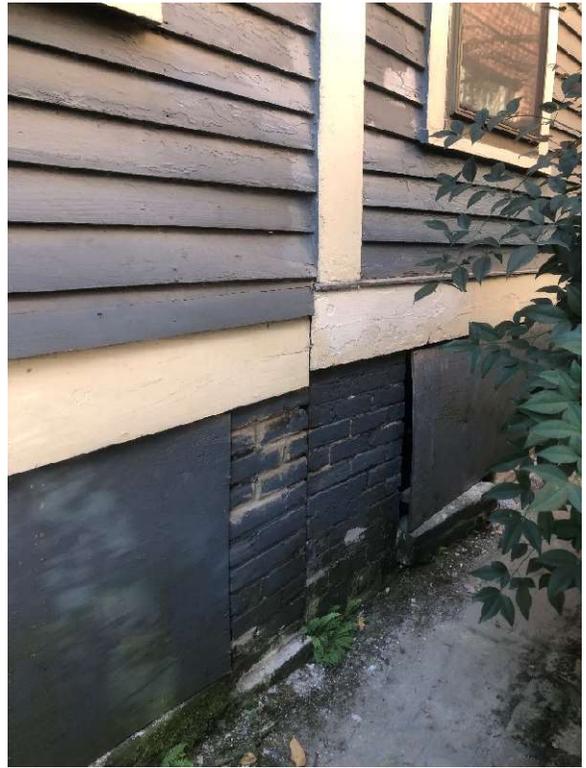
Figure 12. 515 S. Rock Street, trim board connection between original structure and historic addition, 2024.

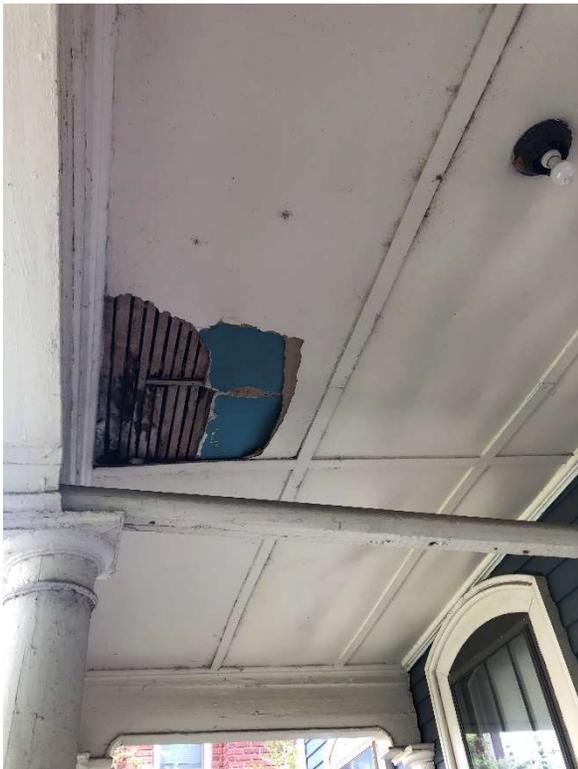
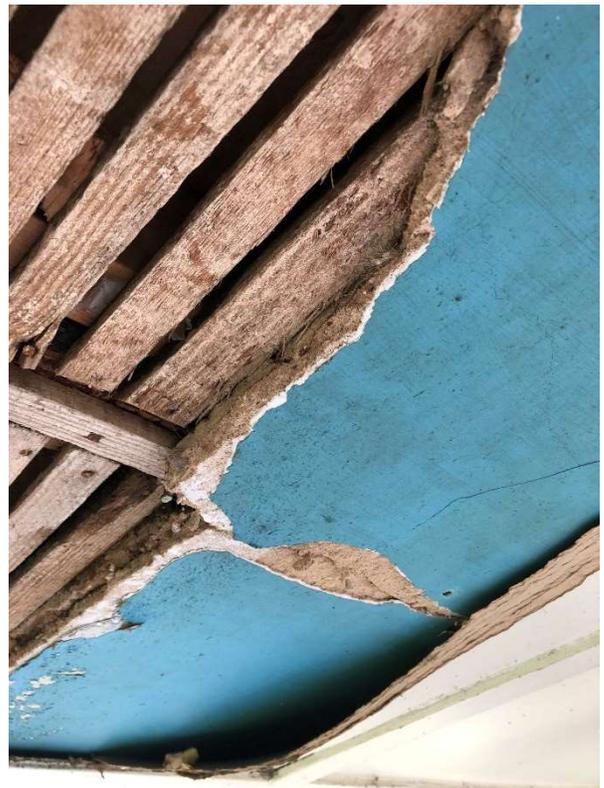
will be replaced (Figure 16), and the porch ceiling will undergo plaster repair (Figure 13, 14). Lastly, the non-original horizontal support beams attaching the columns to the front façade wall will be removed (Figure 15).

Figure 13. 515 S. Rock Street, historic plaster porch ceiling revealed, 2024.

Figure 14. 515 S. Rock Street, historic plaster porch ceiling revealed, close up, 2024.

Porch ceiling – Restore with a smooth plaster finish.

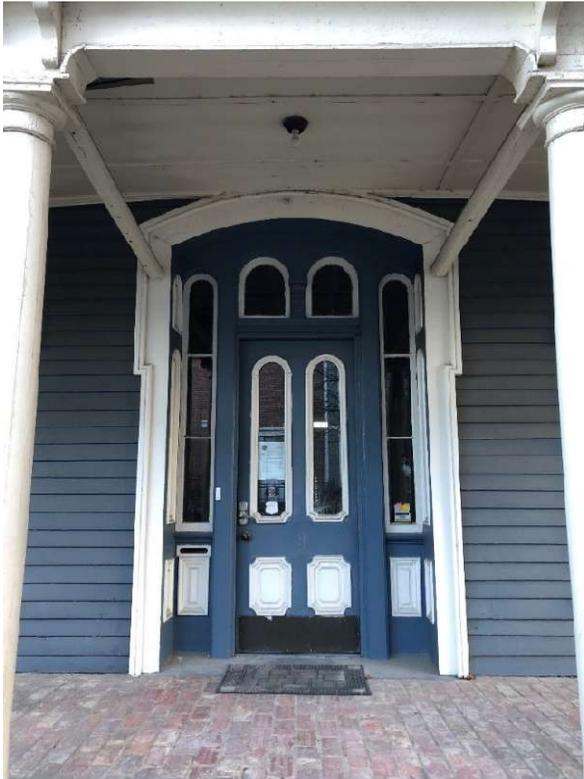
Figure 15. 515 S. Rock Street, front entrance, 2025.

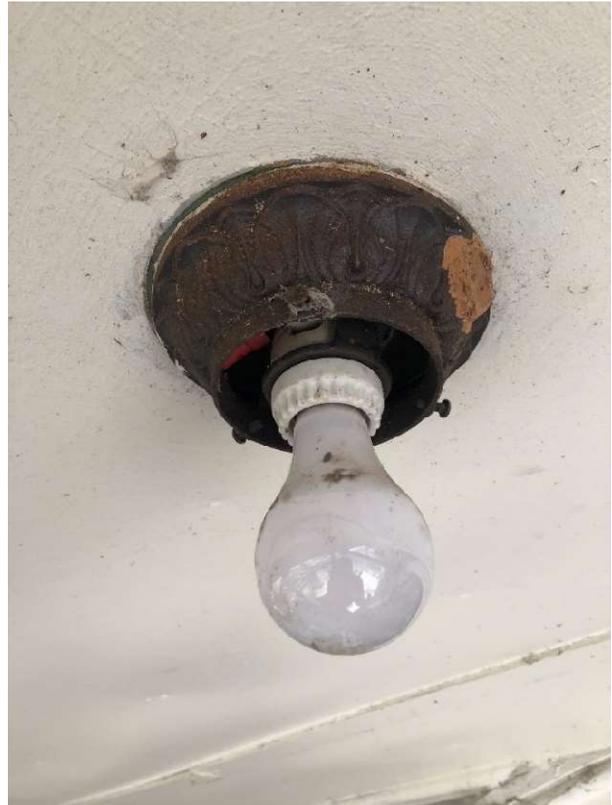
Figure 6. 515 S. Rock Street, exterior porch light above entrance, 2024.

Porch light – Use existing fixture location or add 2 ceiling mounted lights centered above windows.

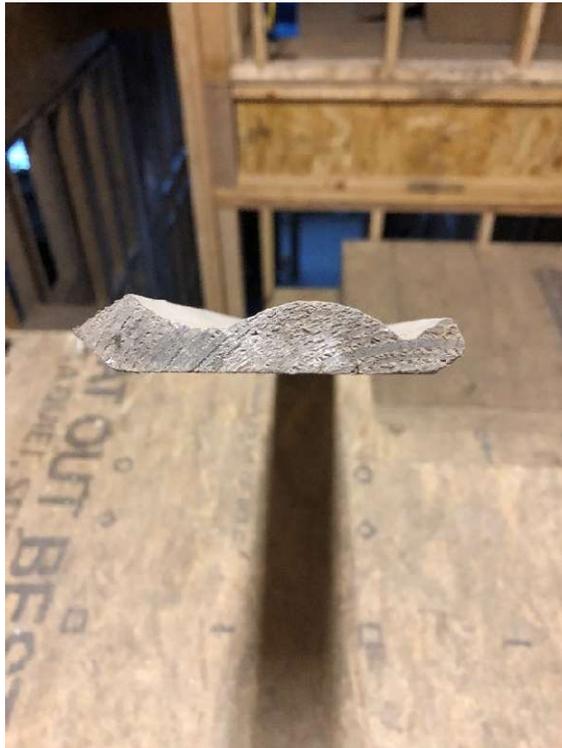
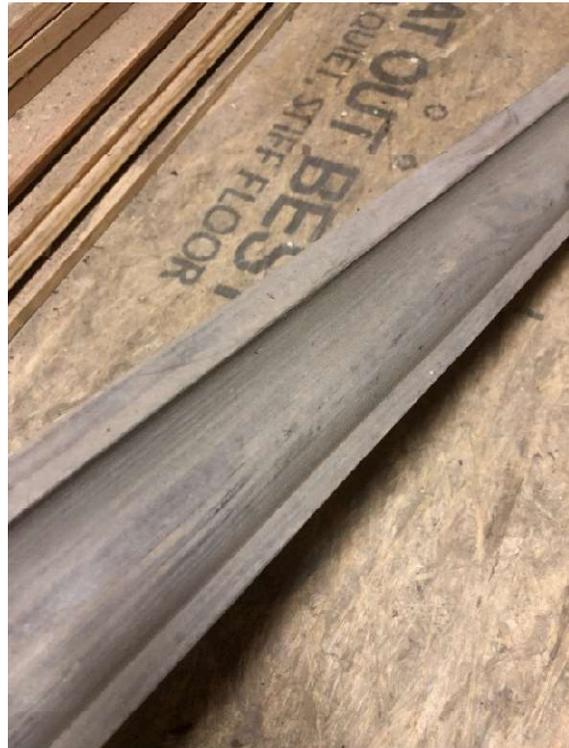
The existing columns will be repositioned to align with the original foundation location and roof elements. Missing eave brackets will be reconstructed, and the fascia will be repaired and rebuilt as needed, based on physical evidence of the original fascia found in the structure’s attic (Figure 17, 18). The existing porch light

Figure 17. Fascia crown discovered in attic of 515 S. Rock Street.

13 Figure 18. Fascia crown discovered in attic of 515 S. Rock Street.

Fascia crown on house and porch – Replace with crown that matches the old photos.
