NAME: Welch-Cherry House – Exterior Alterations, ADA Handicap Ramp

LOCATION: Welch-Cherry House, 700 S. Rock Street, Little Rock, 72202

B. <u>PROPOSAL/REQUEST/APPLICANT'S STATEMENT:</u>

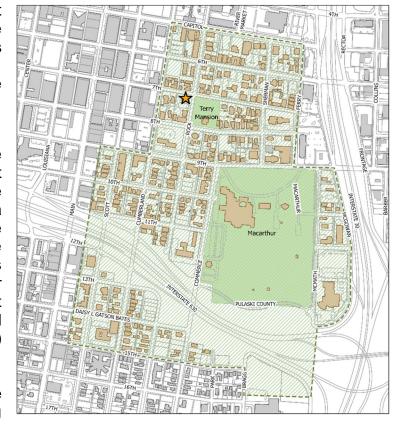
The Welch-Cherry House displays a compound front-facing T plan with an asymmetrical front

gable and cross-gable roof. The home displays subdued Italianate details, such as tall and narrow two-over-two wood windows with hooded, segmental arches, and simple eaves with built-in gutters. Frame partial porches, single-story and two-story, sit against each elevation with collective square porch supports with beveled (chamfered) corners. Masonry details include brick window hoods and courses

parged and painted to appear like stone. The first story belt course along the street facing facades is precast concrete or stone. Uniquely, the home retains its original slate tile roof and five brick chimneys. The home lacks common ornate Italianate details such as cornices and eave brackets.

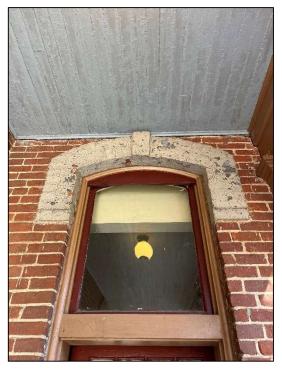
The application proposes to remove the paint from the brick masonry window hoods and second story belt course. Typically, the removal of paint from masonry would be supported and encouraged by the Design Guidelines and the SOI standards. However, there is physical evidence to suggest that the brick belt course and window hoods were originally parged and painted to resemble stone. For this reason, the removal of paint and parge coating needs to be considered. Staff recommends the additional investigation of the window hoods and belt course and consultation with the AHPP and NPS regarding best practice in this circumstance.

Figure 10. 700 Rock Street, front porch brick window hood with parge coating and paint.

- 1. The proposed siding on the rear porch be exchanged for simple solid panels below the windows to avoid conjecture.
- 2. The accessibility ramp be composed of wood with wood railings or a simple, dark colored metal ramp system that can be easily removed.
- The owner will consult technical staff at the Arkansas Historic Preservation Program and National Park Service to determine whether paint should be removed or if parged coating reapplied and repainted on the window hoods and second story belt course.

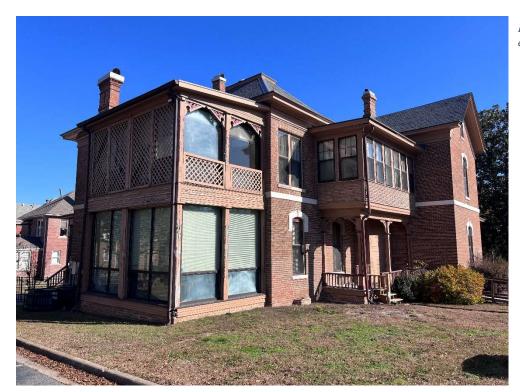
The application proposes to remove existing lattice panels and metal floor-to-ceiling window wall system installed in the 1984-1985 restoration and rehabilitation of the property. The porch enclosure system will be replaced with wood (Spanish cedar) one-over-one non-operable windows with exterior mullions, arranged two and three per bay. Wood horizontal siding and trim in the same dimensions and exposure are proposed beneath the windows to match the south elevation porch.

Figure 13. 700 S Rock, south and west elevations, rear porch, 2023.

District. To more clearly differentiate the periods of enclosure between the south elevation porch, and the modern enclosure of the rear porch, staff recommends either the proposed siding be exchanged for simple solid panels or the enclosure system as a whole be reconfigured to consist of larger glazing without divide lights and a lower solid panel at porch railing height.

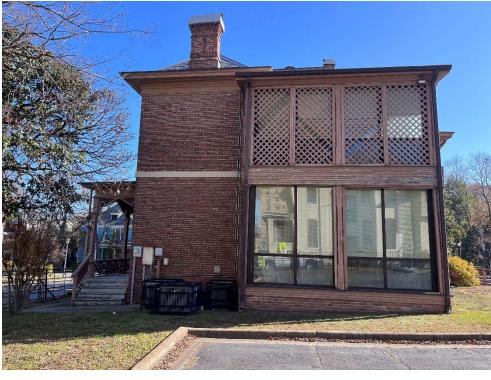
Figure 14. 700 S Rock, west elevation, rear porch, 2023.

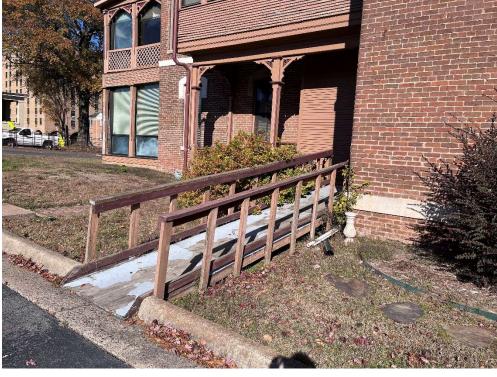
The application proposes the removal of the existing wood accessibility ramp on the south elevation and replacement with a concrete ramp and metal handrails. The ramp will connect the south porch to designated handicap parking.

Figure 16. 700 S Rock, south elevation, side porch and existing accessibility ramp 2023.

Staff finds the accessibility ramp is <u>inconsistent</u> with the *MacArthur Park Historic District Design Guidelines* in material and screening. The proposal is <u>consistent</u> with the *Design Guidelines* and *Secretary of Interior's Standards for Rehabilitation* in location. Staff recommends a wood accessibility ramp in consideration of the structure's architectural style, historic use, and materials. Concrete accessibility ramps are more appropriate on commercial and institutional structures that are an extension of the sidewalk to a storefront or entrance. A simple black, modular, metal accessibility ramp might also be more appropriate than concrete since it can be removed if needed.

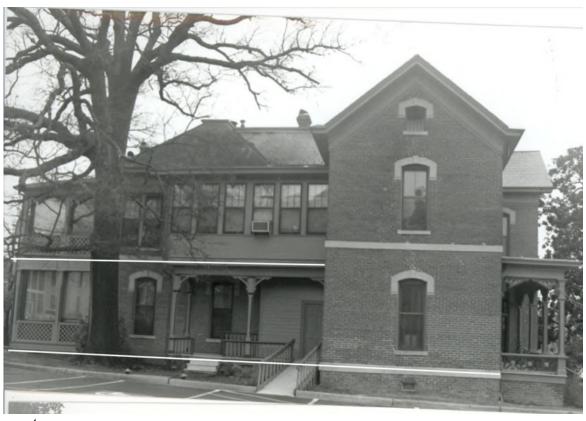
$4a.\,$ SOUTH ELEVATION circa 2007

- 1. ROOF: Repair existing roof assembly including flashing, box gutters, downspouts and eaves. Provide theftproof splash blocks. For pictures see Home Buyer's Protection attachment and inspection by Bray Sheet Metal.
- 2. MASONRY REPAIR AND STABILIZATION: Provide stabilization for house and porches including but not limited to walls, foundations and rebuild 2 leaning chimneys. All brick walls are load bearing masonry. All porches indicate vertical foundation movement. Include replacing non-matching mortar in color and strength. Eliminate moisture infiltration. Flashing shall be recessed in brick joints, not adhered to brick. See Home Buyer's Protection attachment and Roberts McNutt attachment.
- 4. REAR (WEST) ENCLOSED PORCH: Replace foundation which is settling see attachments 3 and 4a below. Horizontal lines drawn indicate how much movement has occurred since 2007 in attachment 4a.

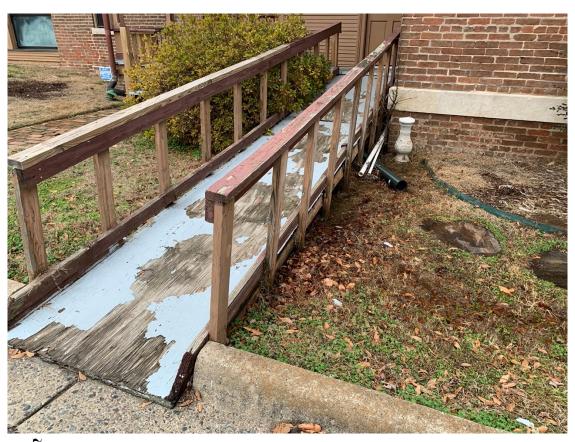
$\boldsymbol{7.} \text{ SOUTH ELEVATION RAMP}$

- a. ADA COMPLIANCE: Replace existing south ramp due to wear. Add handrails for front (east) porch. Provide striping connecting ramp to driving lane and handicap parking sign at designated parking space. Move handicap parking space next to ramp, add handicap parking sign and add logo on asphalt. Add code compliant handrails. See attachments 4,5,7,10,15, 17,19.
- b. SIDEWALKS: Replace existing for safe travel where damaged including the front steps. See attachment 20.

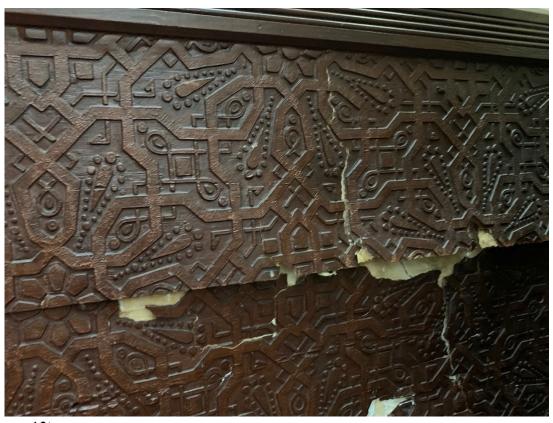
17. LINCRUSTA

- 9. REPAIR INTERIOR DAMAGE DUE TO LACK OF MOISTURE STABILIZATION: Repair all existing finishes and substrate. See attachment 17 for damage to lincrusta wall covering.

3. REPAIR INTERIOR DAMAGE AFTER EXTERIOR MOISTURE STABILIZATION IS COMPLETE: REPAIR ALL EXISTING INTERIOR FINISHES AND SUBSTRATE DAMAGE. LINCRUSTA WALL COVERING SHALL BE STABILIZED AND REPAIRED OR REPLACED (TO BE DETERMINED).
