FILE NO.: HDC2024-015

NAME: 1017 S Cumberland – Exterior Alterations, Reconstruction, Rear Addition, and Fencing

LOCATION: Newby House, 1017 S Cumberland, Little Rock, 72202

A. BACKGROUND

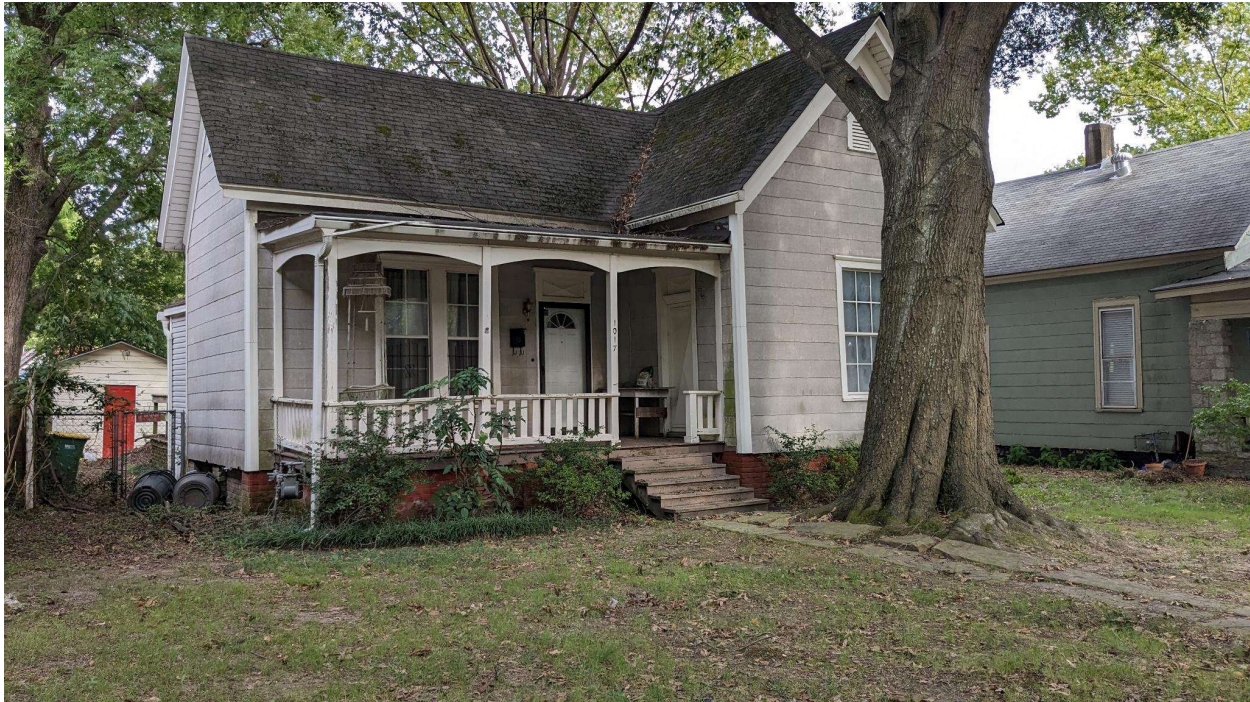
Figure 1. 1017 S Cumberland, front facade, looking east.

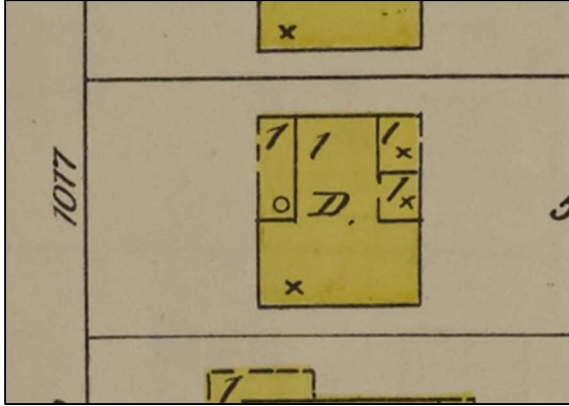
Figure 3. 1017 S Cumberland Street, Sanborn Map, 1897.

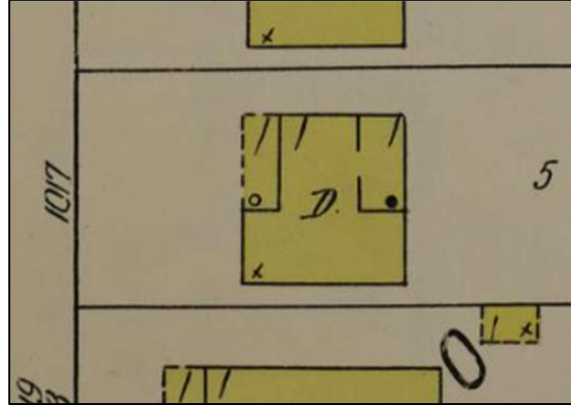
Figure 4. 1017 S Cumberland Street, Sanborn Map, 1913.

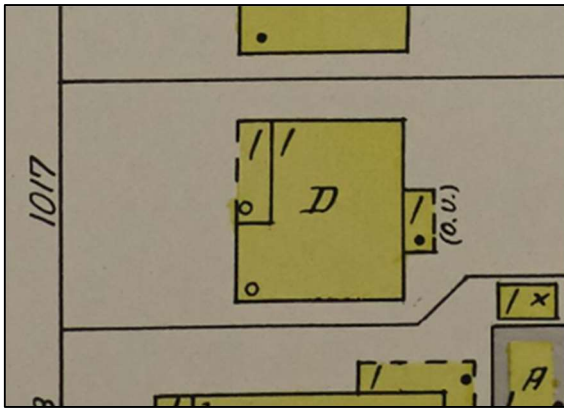
Figure 5. 1017 S Cumberland Street, Sanborn Map, 1939.

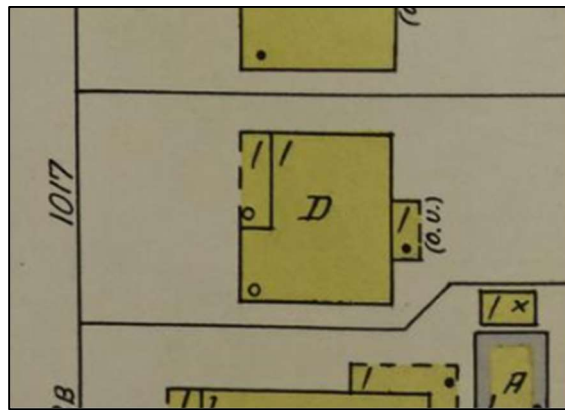
Figure 6. 1017 S Cumberland Street, Sanborn Map, 1950.

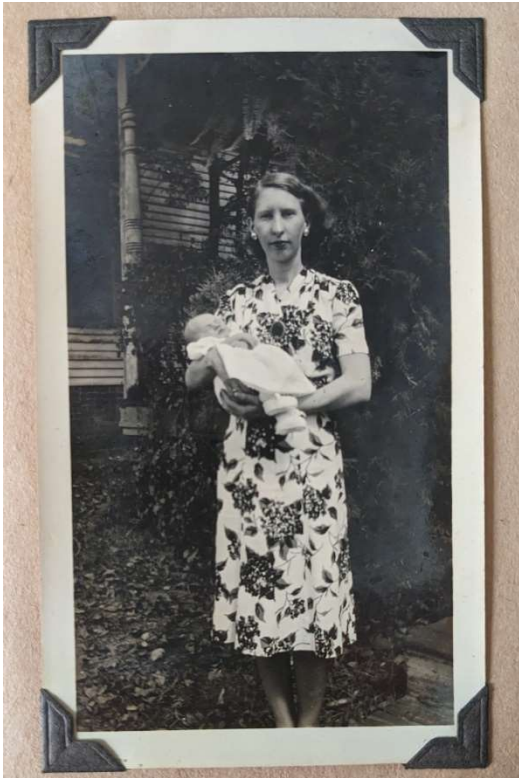
Figure 7. Original front porch posts shown behind Ruth Newby holding newborn daughter Jeanette Newby, 1939. Newby family photo album, courtesy of Matthew Pekar.

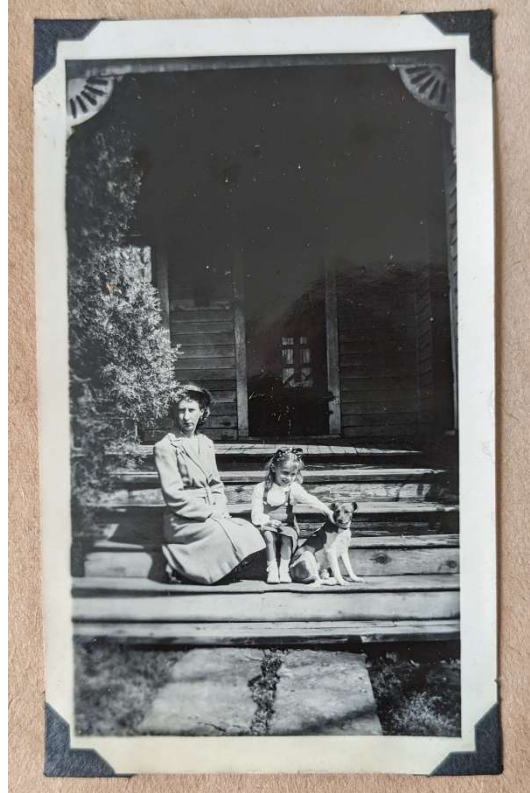
Figure 8. Original front porch shown behind Ruth Newby, Jeanette Newby, and family dog, 1943. Newby family photo album, courtesy of Matthew Pekar.

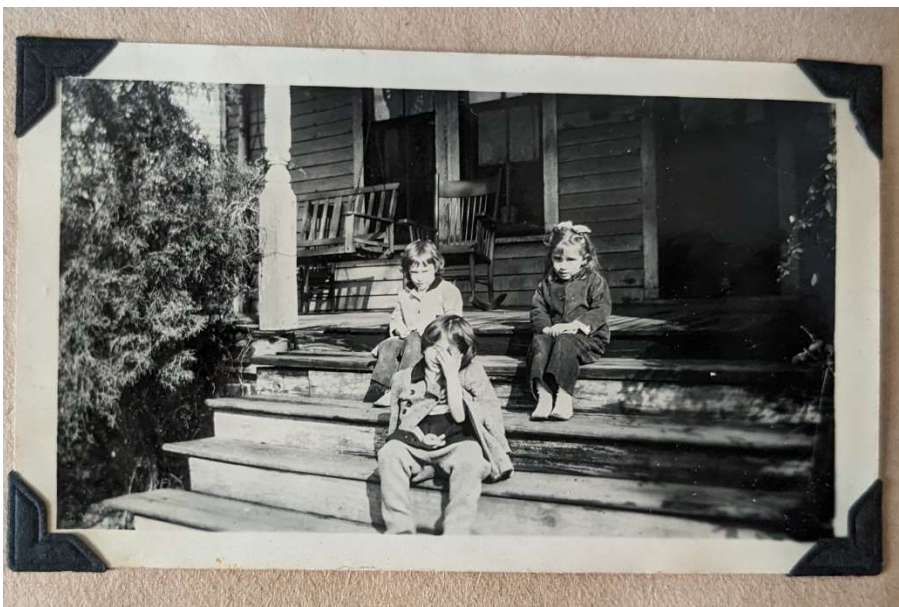
Figure 9. Original front porch shown behind Jeanette Newby and friends, 1943. Newby family photo album, courtesy of Matthew Pekar.

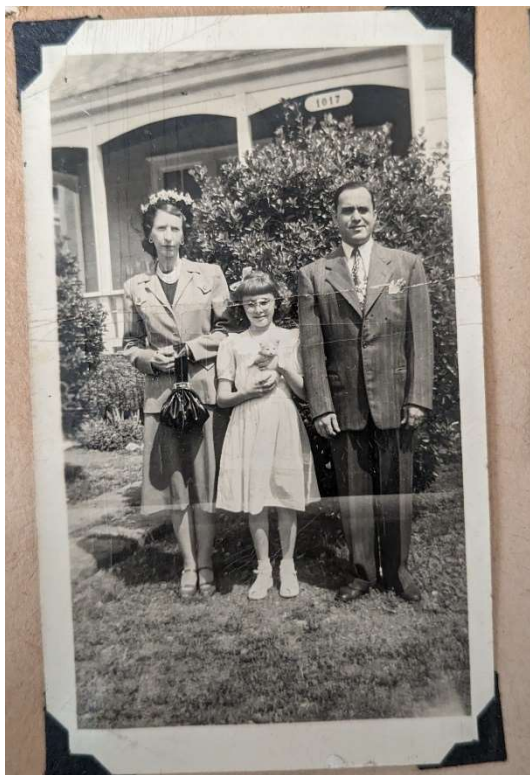
Figure 10. Modified front porch and siding, Ruth, George, and Jeanette Newby, 1950. Newby family photo album, courtesy of Matthew Pekar.

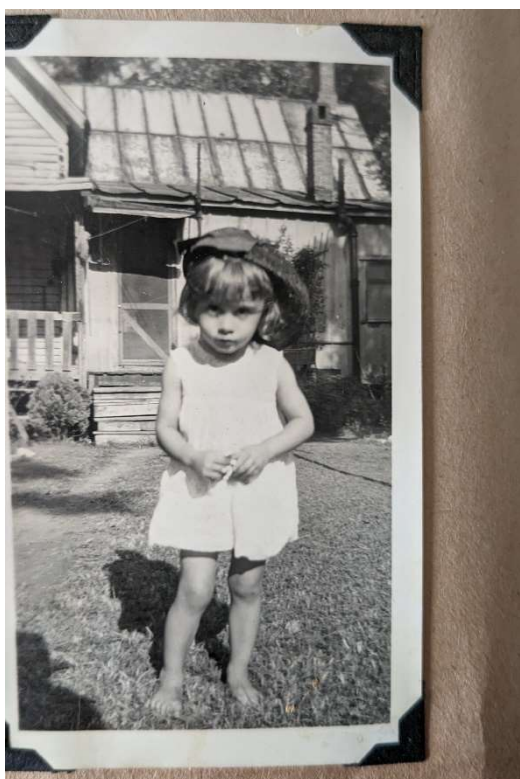
Figure 12. Jeanette Newby in rear yard with rear porch shown behind, 1941. Newby family photo album, courtesy of Matthew Pekar.

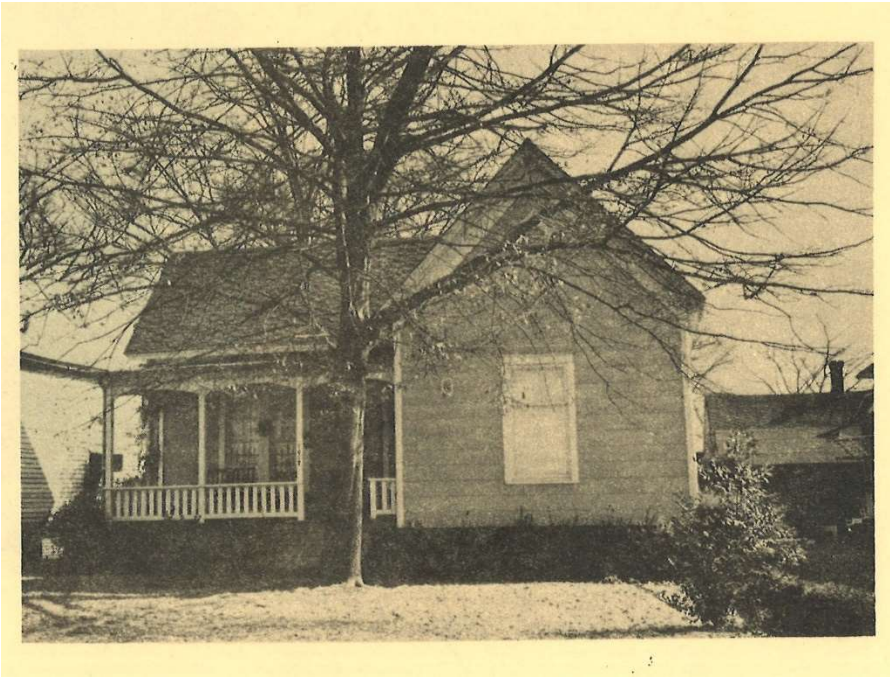
Figure 13. 1017 S Cumberland Street, QQA Architectural Survey, 1978.

The application proposes to replace the front gable six-over-six vinyl window with a one-over-one wood picture window. The replacement window will be designed in the configuration and dimensions of the original window, as shown in Figure 13. The replacement window will be 28" x 56", is manufactured by Heirloom Windows, and features true divided lights, dimensional muntins, and built-in weather stripping. No other existing windows are proposed for replacement at this time.

* Replace the front 6 over 6 window with a 1 over 1 picture window that matches the style seen in the 1977's survey photo of the home.

For the picture window, replace w/a one over one window as shown in the 1977 survey.

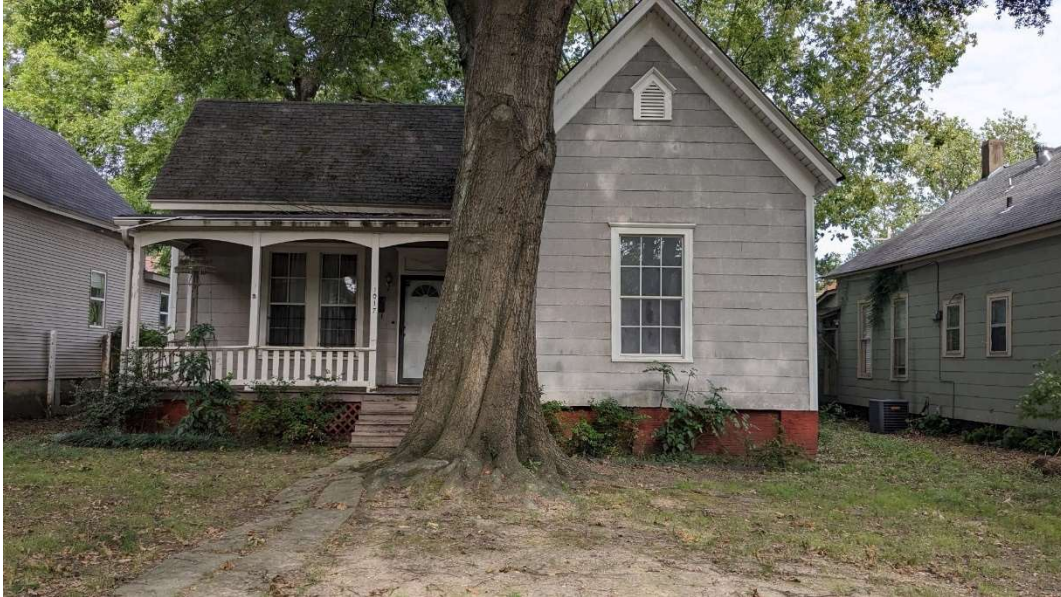
Figure 14. Front facade of 1017 S Cumberland.

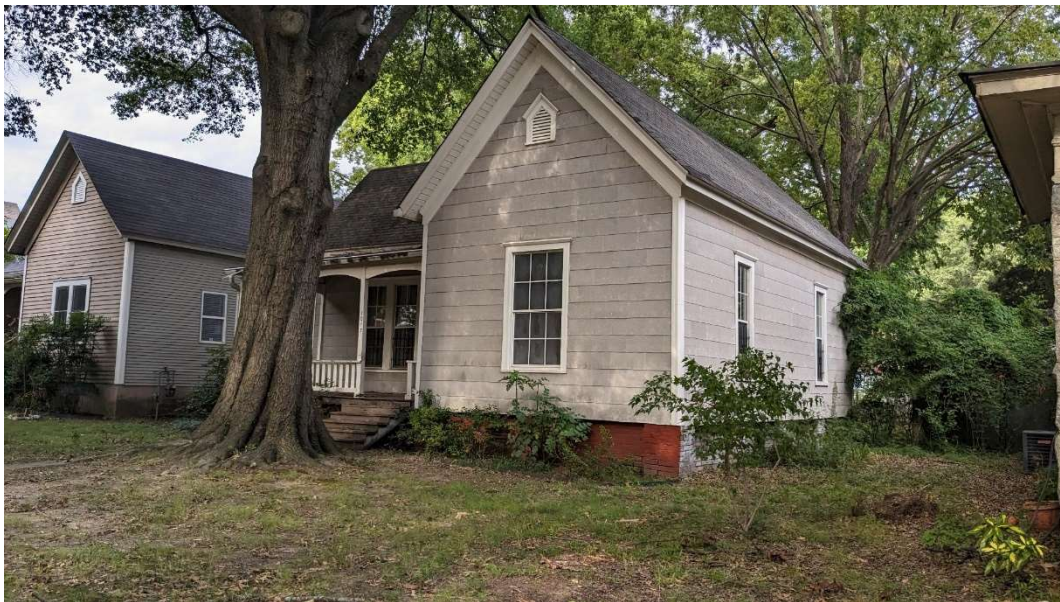
Figure 15. Front facade facing northeast of 1017 S Cumberland.

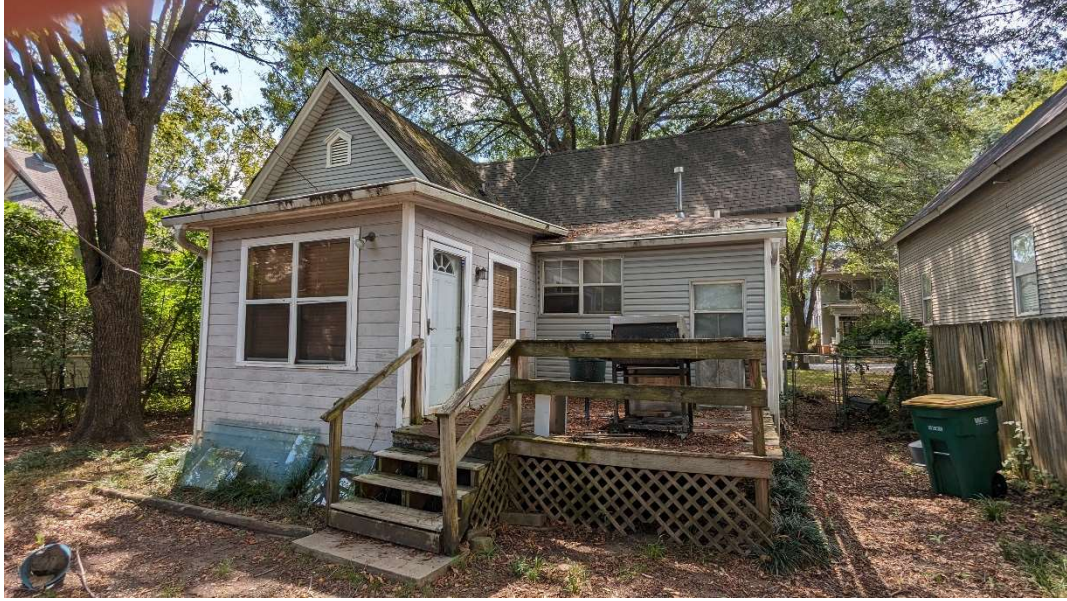
Figure 16. Rear of 1017 S Cumberland.

The application proposes the removal of the existing, non-historic rear addition and the construction of a new addition roughly following the same footprint. The new

attached addition will extend from the east rear wall into the rear yard, will be frame construction clad with wood weatherboard siding supported by a parged concrete block foundation, have one-over-one wood windows, and be covered by a standing seam metal roof with a shed slope.

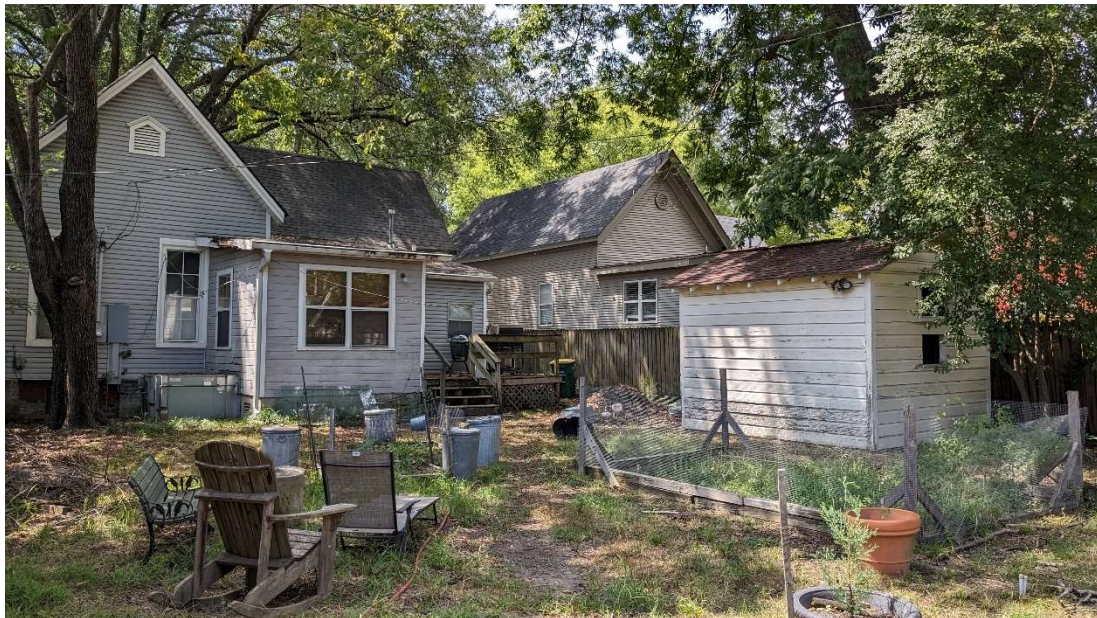
Figure 17. Rear yard of 1017 S Cumberland.

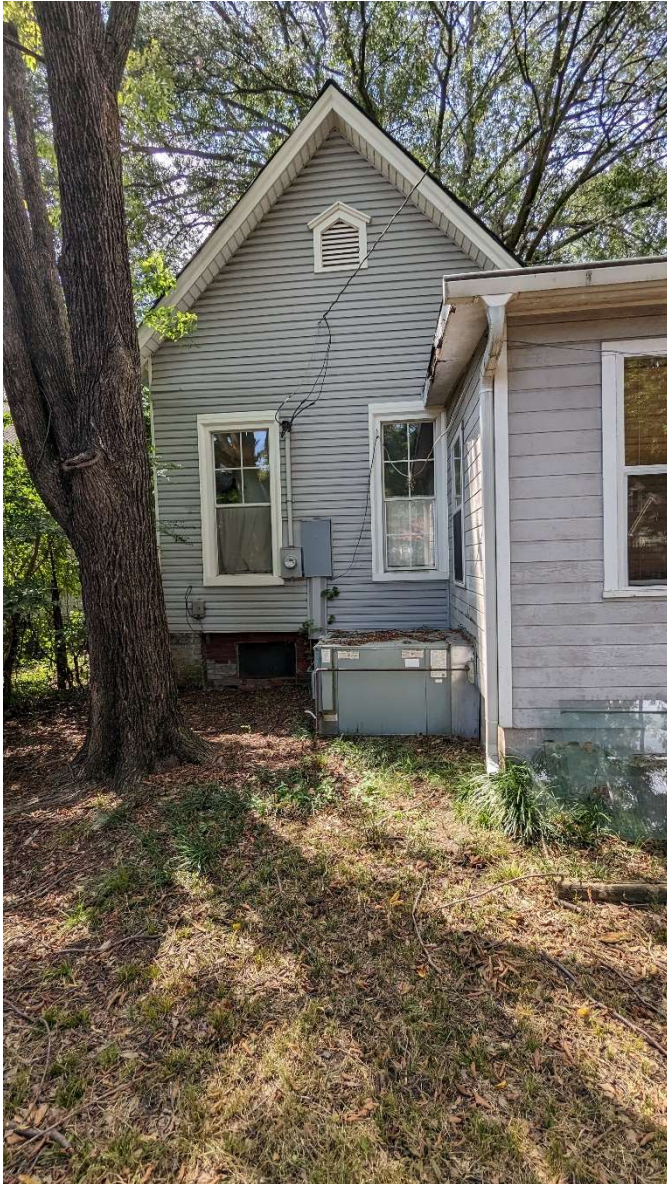
Figure 4. Rear gable of 1017 S. Cumberland.

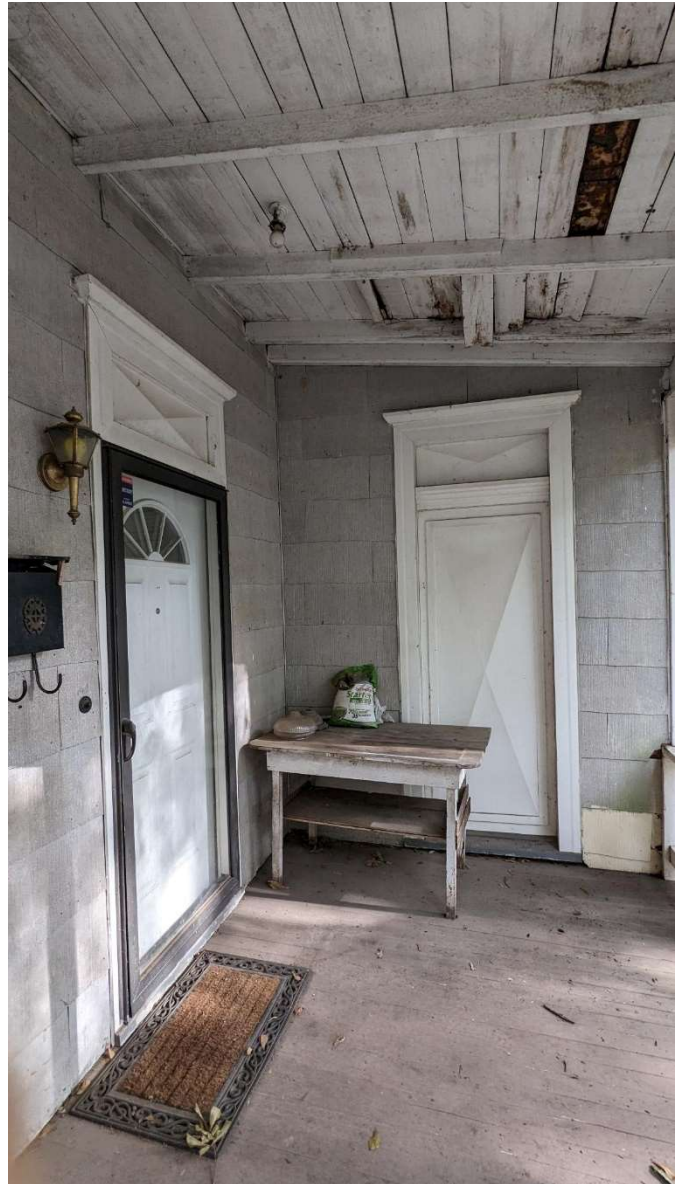
Figure 3. Front porch of 1017 S. Cumberland.

Porch is damaged and in need of repairs.

Repair and replace porch elements in the same style and materials as it currently is.

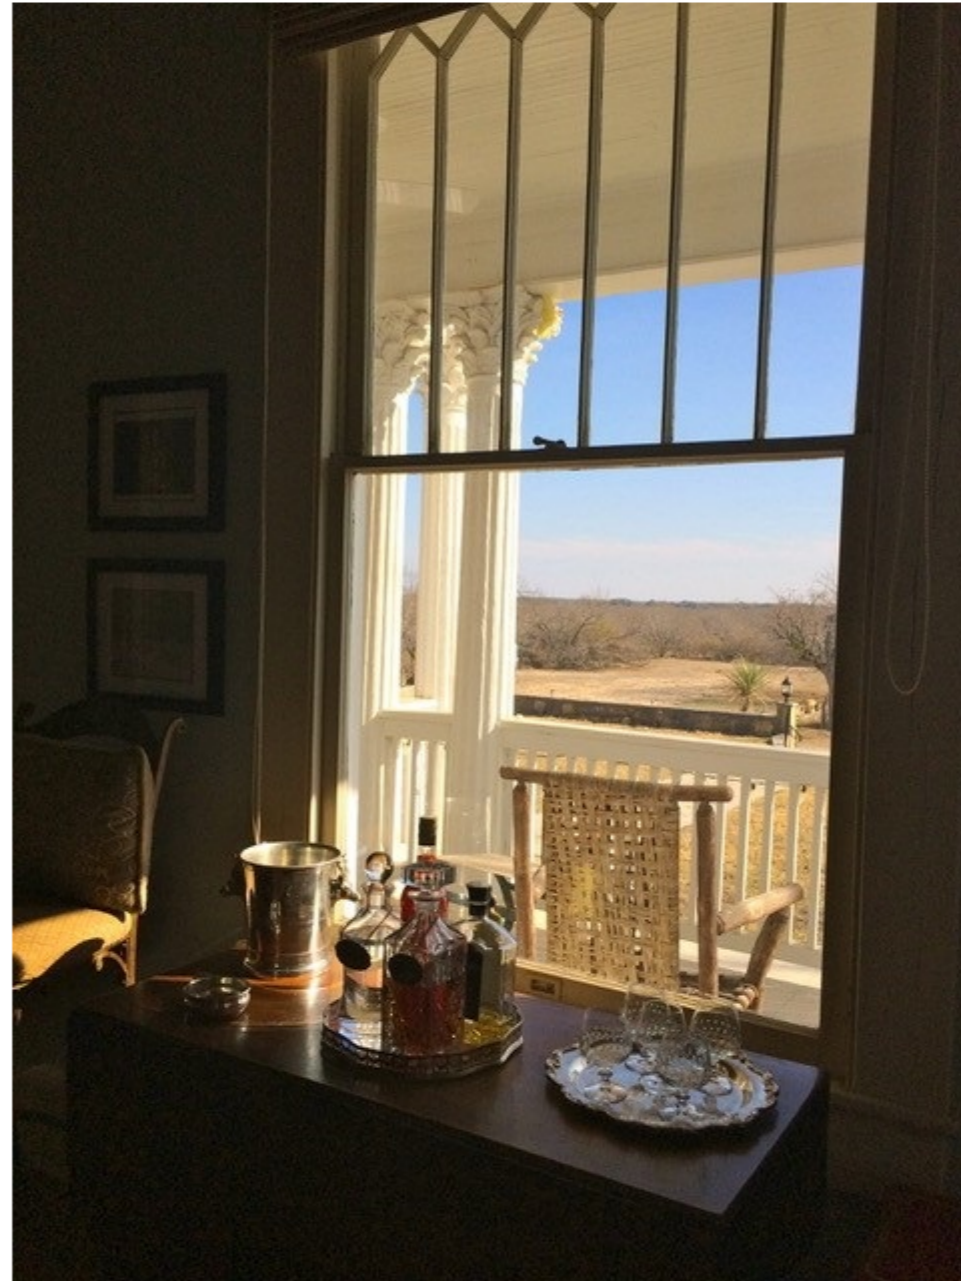
With the combination of thin "Spacia" Vacuum Insulated Glass (VIG) and extremely durable and long lasting "Accoya" wood, our Ultima Windows are by far the most historically accurate and energy efficient wood windows on the market today.

- * Thin VIG allows direct sash replacement old sash for new sash, even keeping original stops
- * Since it resembles a single piece of glass, muntins on VIG look just like True Divided Lite
- * Thin VIG allows preservation of historic profiles and deep shadow lines that define old sash
- * Accoya wood fabric with 50 yrs warranty allows worry free, all wood sash construction
- * Tricoya glazing beads, also with a 50 yr warranty eliminates glazing putty maintenance

Ultima windows are available as a complete replacement sash system (into existing traditional jambs) or as "new construction" configuration using the same sash as Ultima replacement but pre-hung in all Accoya jambs. Ultima windows are available with classic 2 1/4" and 1 3/8" sash sizes.

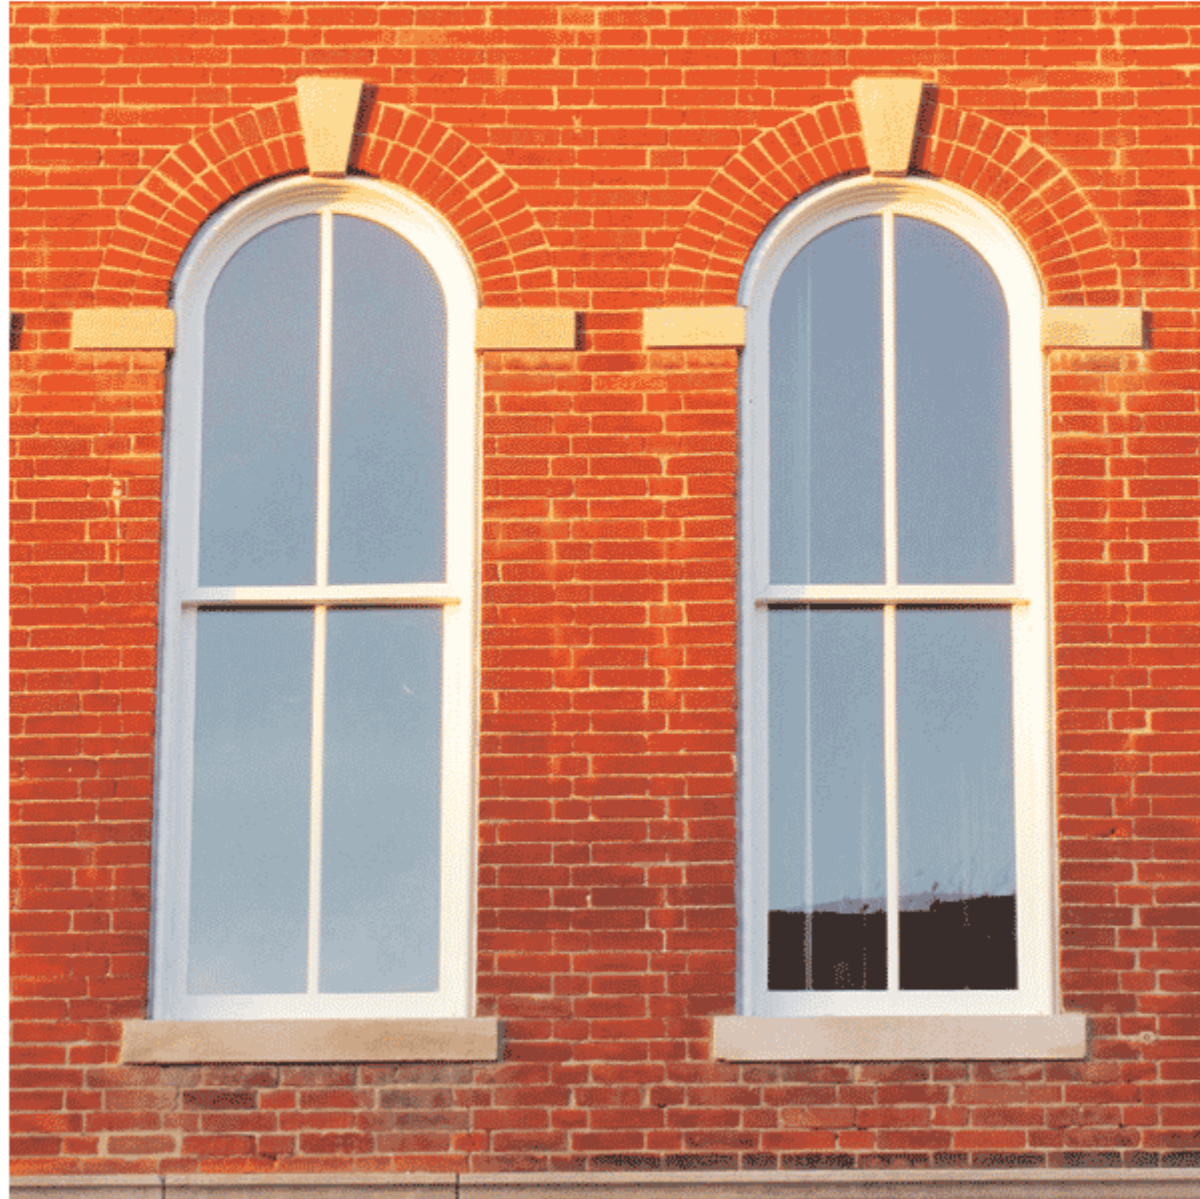
Classic Windows

Our Classic Window Series with monolithic glass is the closest thing you will find to an exact duplicate of your existing windows. With the possible exception of the actual sash molding profile (which we can duplicate also with an up charge), the Classic will have the same rail, stile and glass dimensions as well as any geometric shapes and muntin configurations as your current windows or as you specify. True divided lite (TDL) and wavy glass is available upon request!
